Protection against the hazards of spontaneous glass breakage.

3M™ Scotchshield™ Safety & Security Window Film Ultra Series

Luxury Hotel — Chicago, Illinois

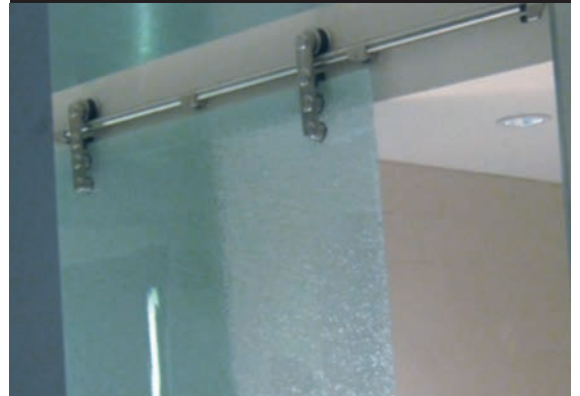
After applying the film and putting the shower door back in place, the glass was broken with a center punch (simulating spontaneous glass breakage). The film successfully held all the glass fragments in place – even after several attempts to manually dislodge the filmed glass panel from the supporting anchor clips. Even after 72 hours, the broken glass shower door remained in place with no glass fragments separating from the film or visible on the bathroom floor.

To prove out the proposed solution, Alan and Associates applied Ultra S400 safety window film to one of the shower doors by removing the glass panel, filming one side of the glass leaving 1/16" of an exposed edge along all four sides, and then trimming circles through the film at the locations where the anchor clips were positioned. The anchor clips overlapped the applied film by only 1/16 to 1/8 of an inch.
